Källösund bridge

A case studie of instrumentation and monitoring of an existing bridge on the Swedish west coast.

The purpose of monitoring was to allow heavy traffic while waiting for strengthening measures to be carried out.

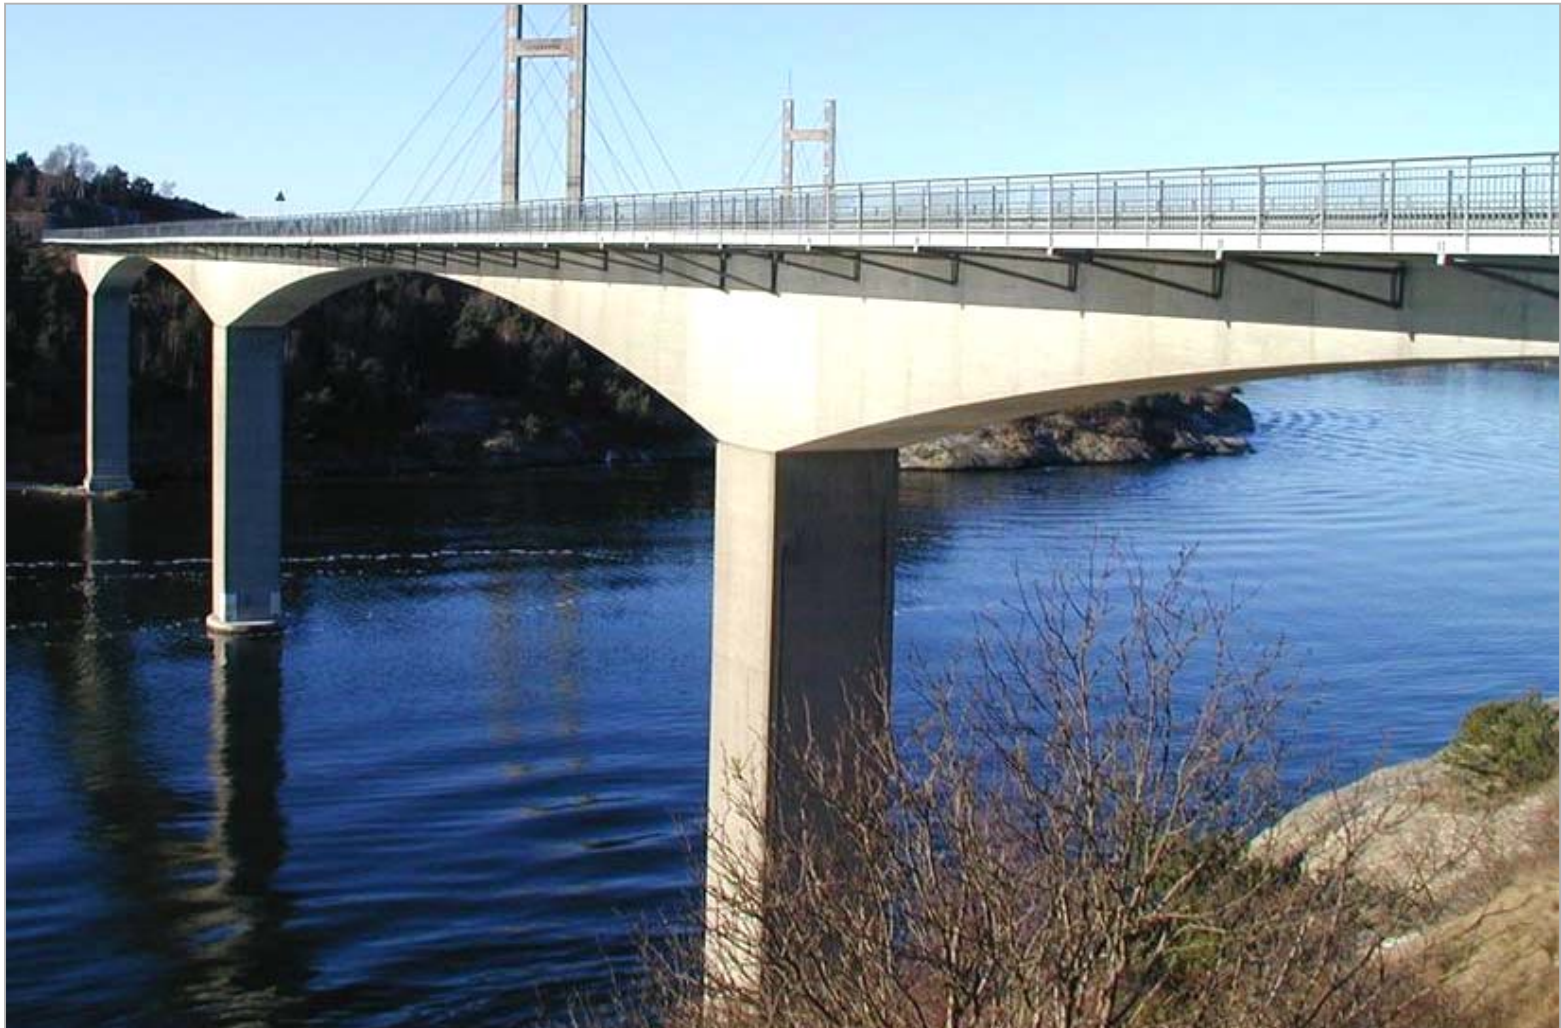
Källösund bridge

Free cantilever bridge

Span 50 + 107 + 107 + 50 m

Built 1960

Traffic 15000 / 24 h

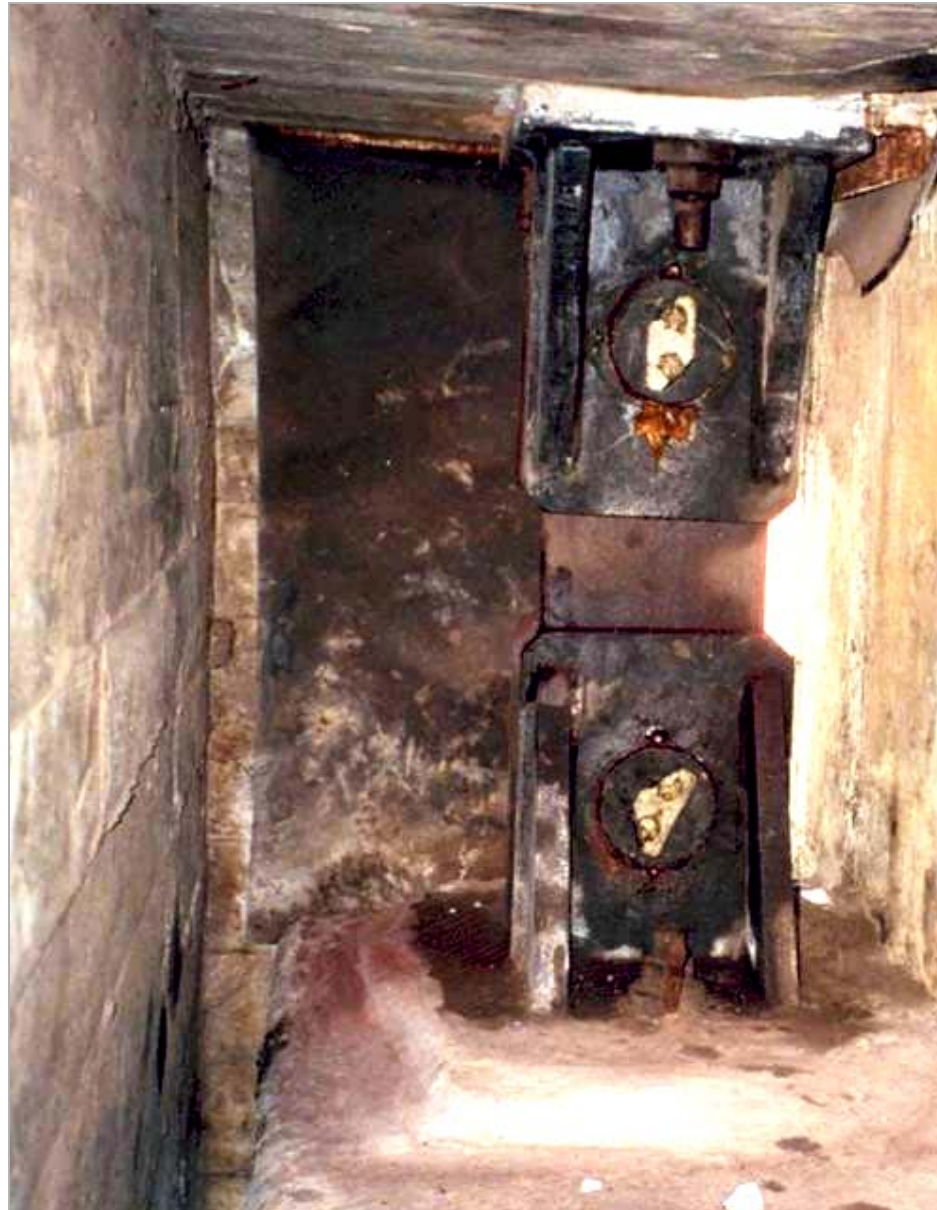
Mid span joints

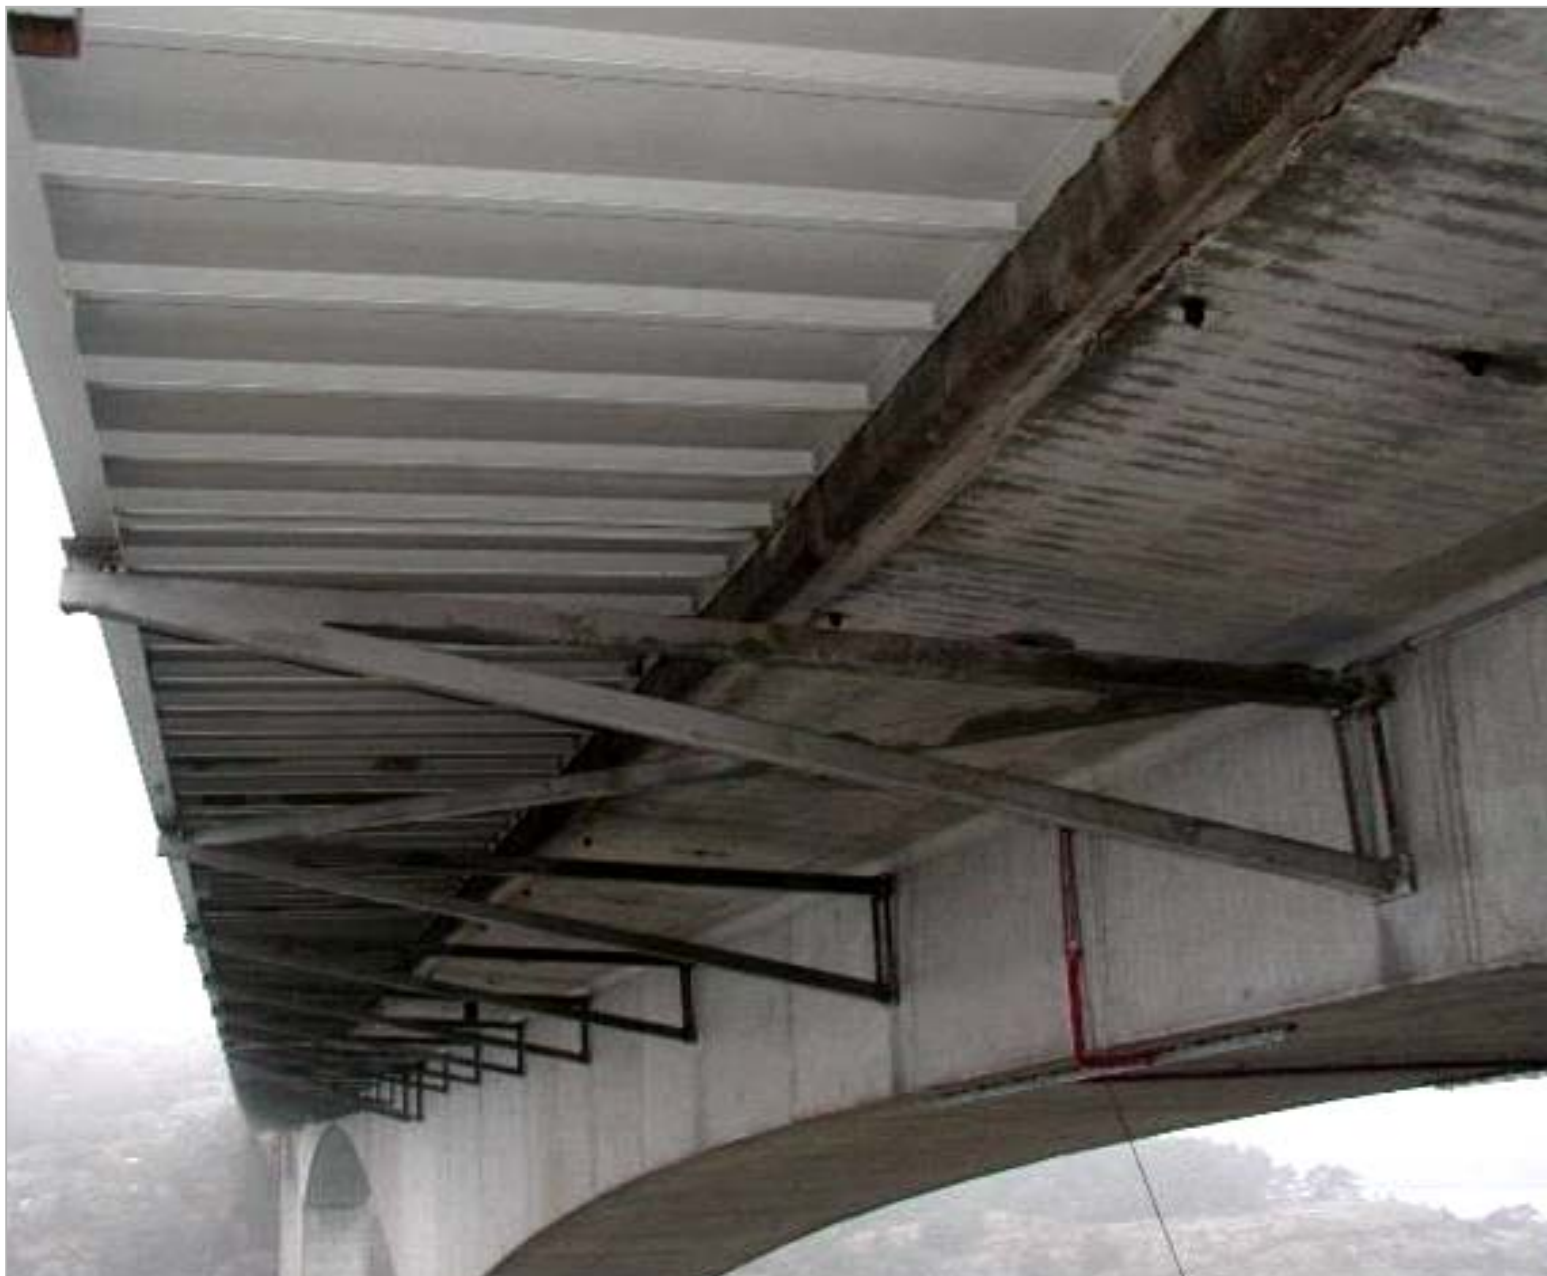
Added public walkway on one side

- Torsion from public walkway was not foreseen in the design
- Very small amount of stirrups
- Webs will be strengthened with CFRP.

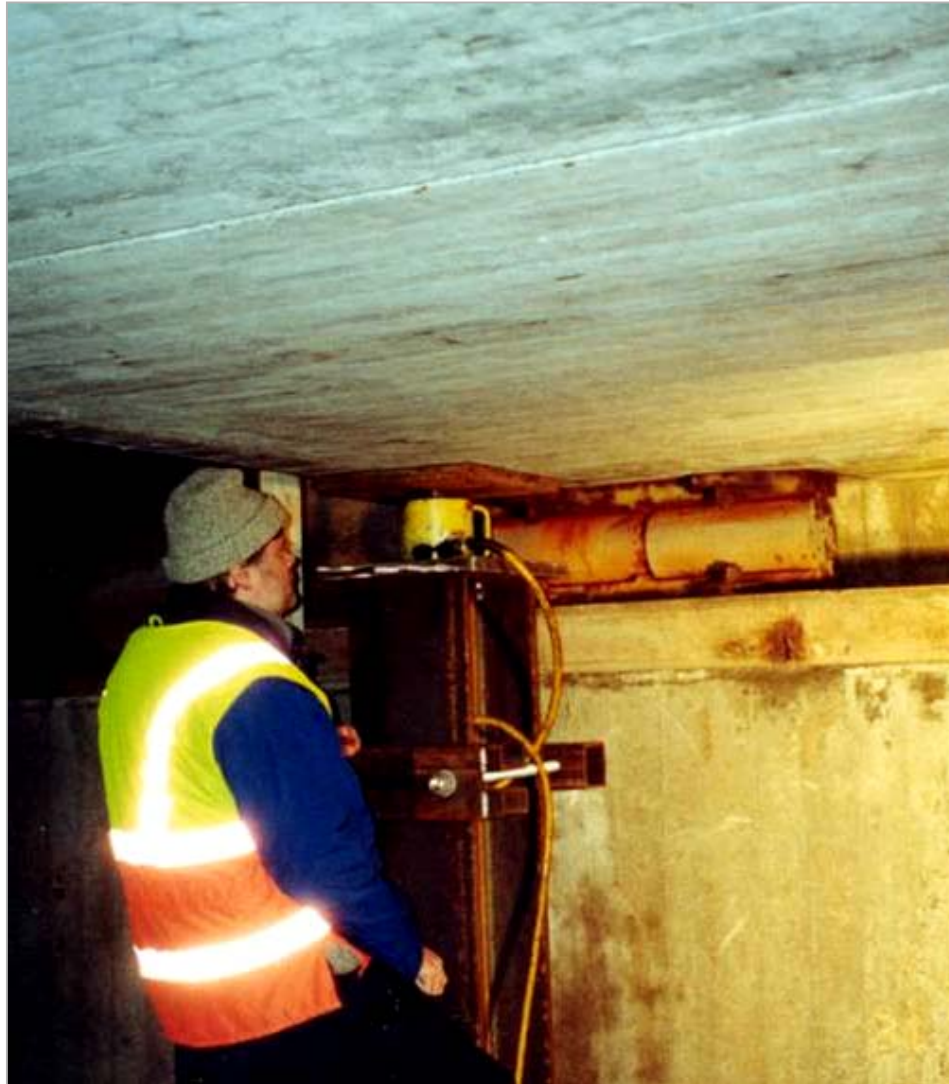
Measuring of self weight reaction at the bridge end to calibrate the creep assumptions

Reason for the sagging moment

The bridge was built with the free cantilever method and then the ends were placed on the abutments. This gives the following chain of events.

- Stress dependent creep will try to lower the free ends
- The abutment will restrain this deformation
- As a result a sagging moment occurs in the outer parts of the cantilevers

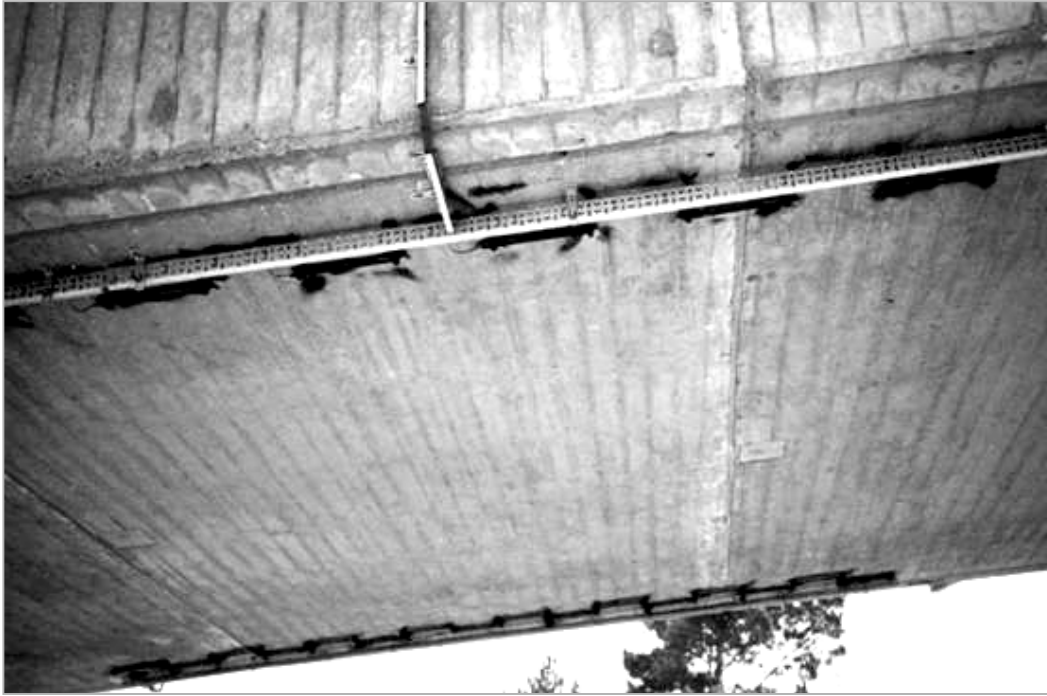
System layout

In areas with insufficient bearing capacity for sagging moments strain gauges were installed along the lower corners of the beam.

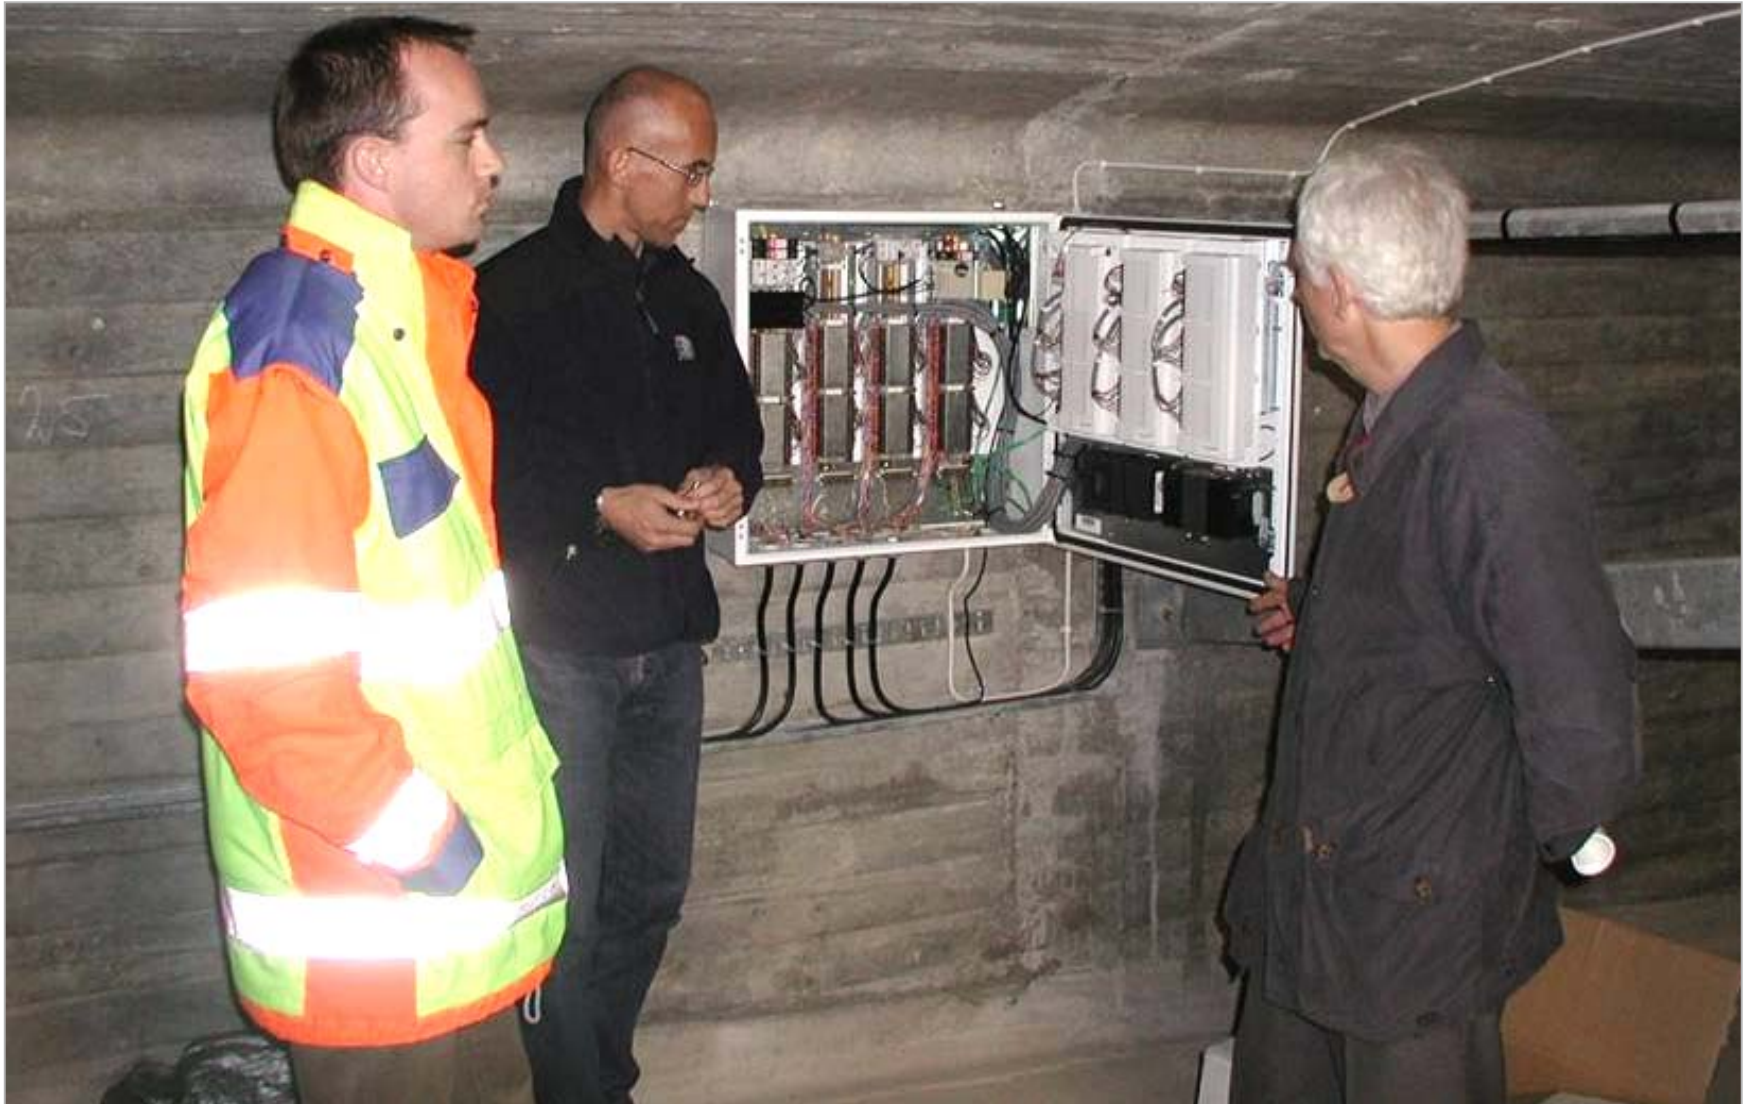
Inside the bridge all sensors are connected via this cabinet

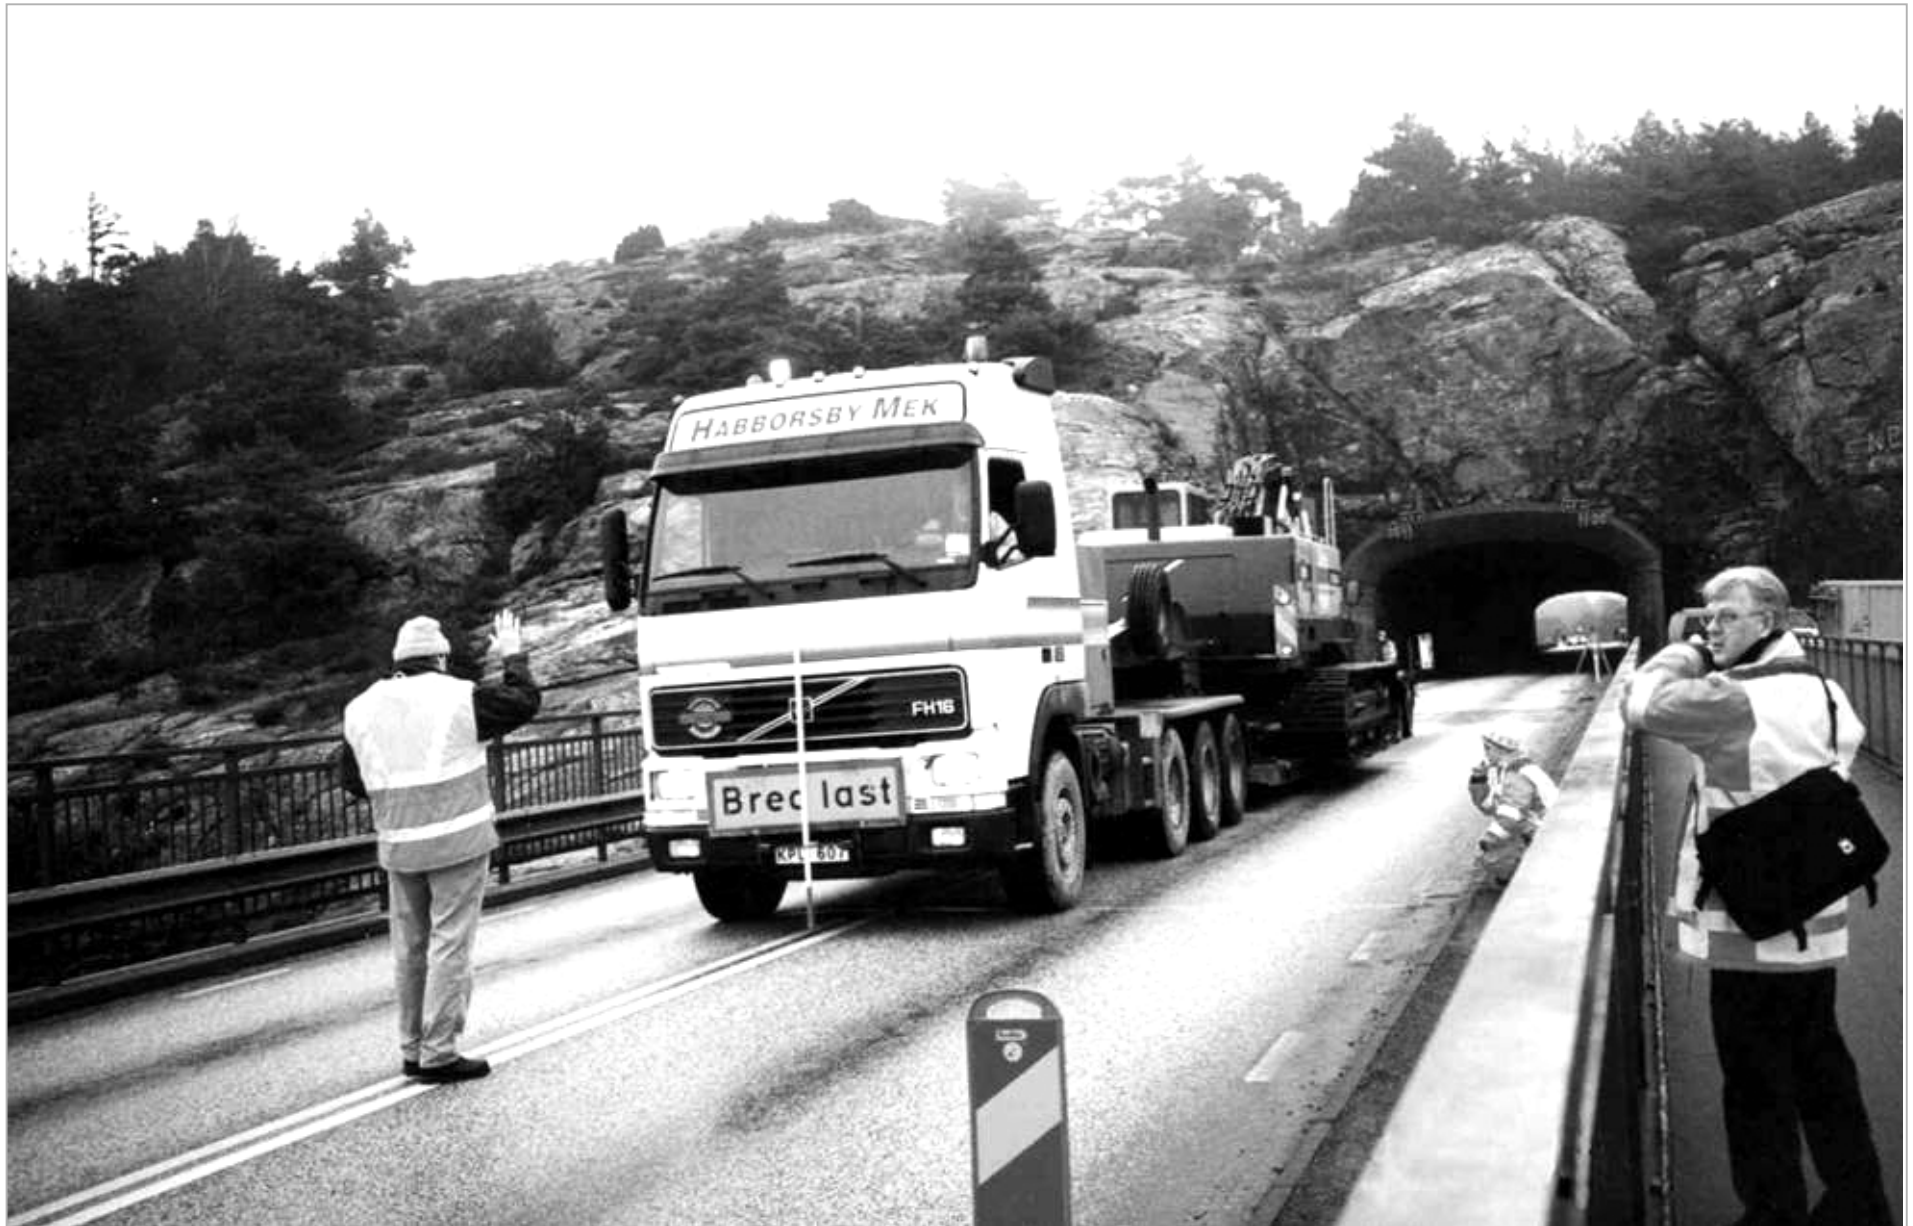
Load test of instrumentation

- A load test was carried out to verify the assessment calculations.
- As load a 70 ton truck was used.
- Due to traffic considerations the load test was done at night. (*Well, there was an attempt....*)
- The test showed a fine correlation between calculated and measured strains.

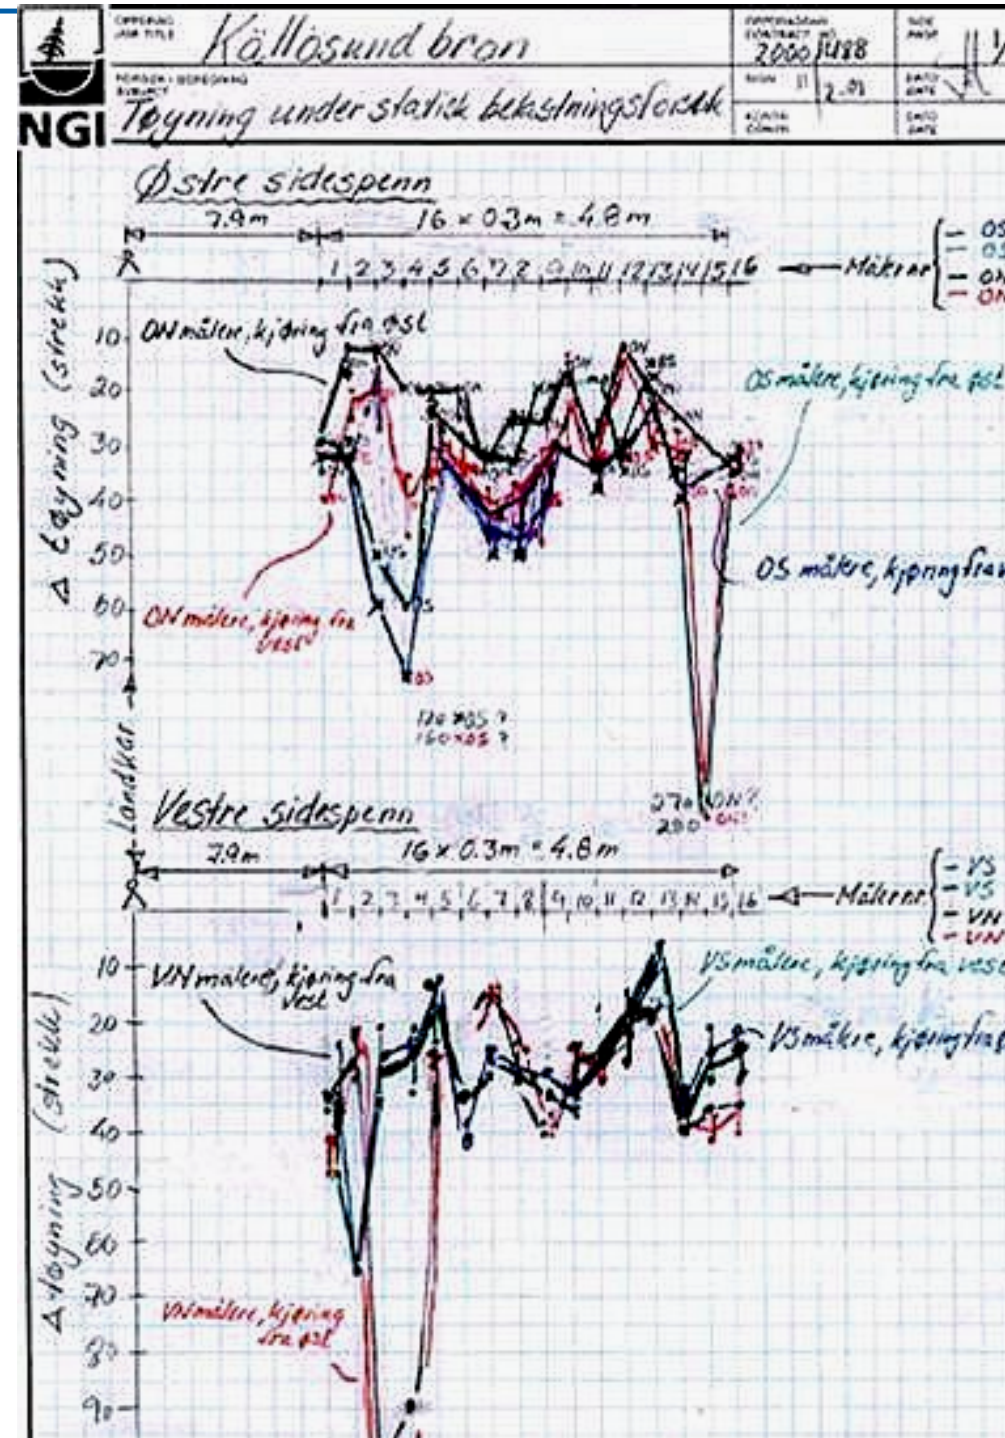
Load test results

Calculated strain was 50 microstrain for "cracked" concrete

The test showed a mean value of 40 microstrain

Peak values of up to 280 microstrain were registered at casting joints that had been found to be cracked
