## **WORK PACKAGE 9: PRACTICAL BRIDGE MANAGEMENT**

#### **D.9.1.2 “Identification and Analysis of Case Stories.”**

Identification and Analysis of Case Stories.

## **Annex A.1. Skovdiget bridge over railway - Denmark**

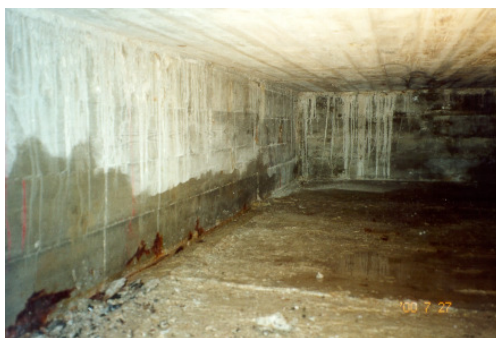
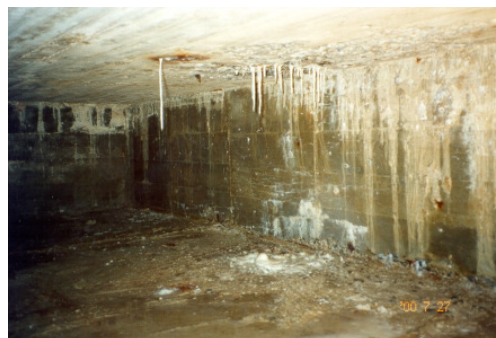
**Fig. A.1.4.** View of the interior of the cell over the railway facing north (Left: western side, right: eastern side of cell).

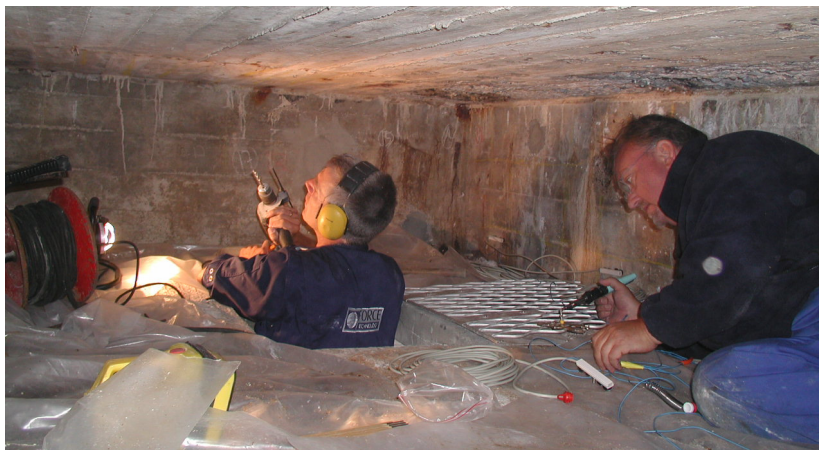
**Fig. A.1.6.** Installation of sensors in cell over parking lot (the third person is behind the camera).

It was therefore decided to use a test version of a new type of sensor “CorroEye”, which could be mounted on the surface, instead of more traditional sensors (as the CorroRisk-sensors combined with a Combisensor).

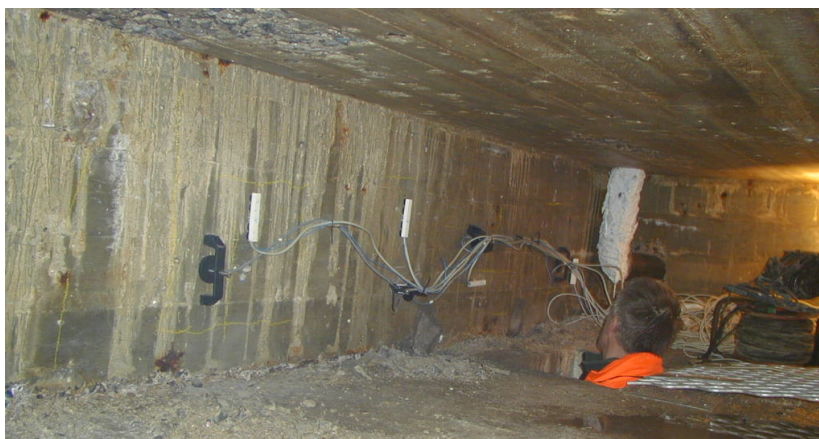
**Fig. A.1.7.** The cell over the railway after the sensor installation.

The moisture is monitored with HUM-sensors, as their signals would have a minimum of temperature dependence and as they are easy and fast to install. Standard temperature sensors were installed.

The cables are mounted on the walls in the cell and lead through a drilled hole at the bottom, down to a stainless steel box 2-3 m below the main girder. The data collection of the moisture and temperature is carried out by battery-driven dataloggers and are powered by a battery, which is loaded by solar cells. The corrosion rate sensors are logged manually, using the same NDT-equipment (GalvaPulse) as were used for the NDT-mapping of the corrosion rates.

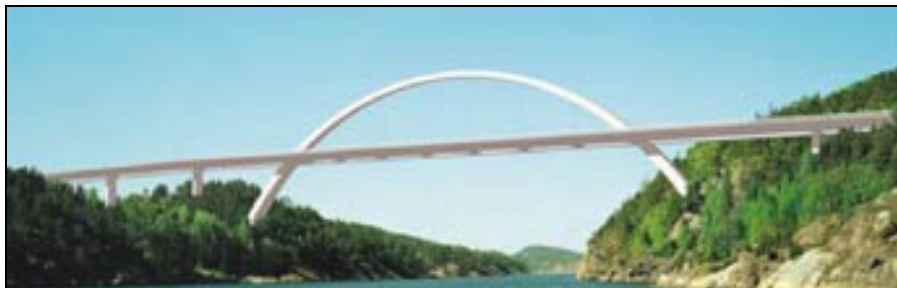
**Fig. A.2.1.** An artist's impression of the New Svinesund Bridge joining Sweden and Norway. The main span is a single arch with a bridge deck on either side of the arch.

The New Svinesund Bridge that is under construction between Norway and Sweden is an elegant but structurally complicated bridge as it combines a very slender construction with a special structural form. The bridge will be opened in 2005 and will be the world's largest single-arched bridge.

The world's largest bridge with a single arch is being built across the Ide Fjord at Svinesund. The design of the new road bridge is a result of an international design contest. The bridge will form a part of the European highway, E6, which is the main route for all road traffic between Gothenburg and Oslo and currently has an Average Annual Daily Traffic (AADT) of 8,000 vehicles, whereof 15 per cent are heavy goods vehicles.

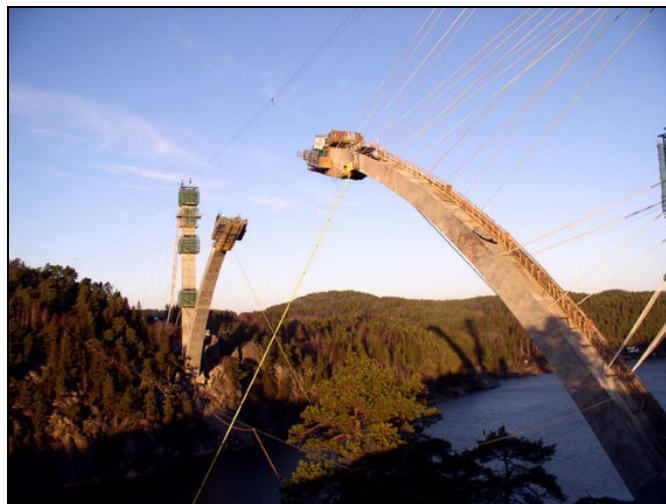
Fig. A2.2. Photograph of the arch under construction.

The construction of the arch uses a climbing formwork and is done in parallel on the Norwegian and Swedish sides. During the construction phase, the arch is supported by cables, which are anchored to temporary auxiliary back-stayed towers, see Figure 2. The towers will be dismantled after completion of the arch. More information on the bridge structure and the construction process can be found in (Brürger, O., 2003).

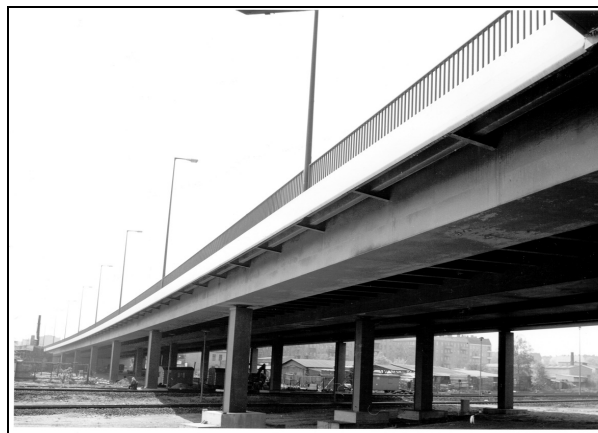
Putlitz Bridge, Berlin, Germany

The Putlitz Bridge in Berlin, Germany, opened in 1977, is part of a main route for urban traffic, which is also used for heavy loads. Currently the bridge is stressed by the transport of heavy gas turbines with maximum loads of 500 t, which is much more than the design loads. To ensure the bearing capacity experimental investigations including SHM have to be carried out.
